NACA RM E53H06

EXPERIMENTAL INVESTIGATION OF SEVERAL WATER-INJECTION
CONFIGURATIONS FOR TURBINE-BLADE SPRAY COOLING
IN A TURBOJET ENGINE

By John C. Freche and Roy A. McKinnon

October 8, 1953

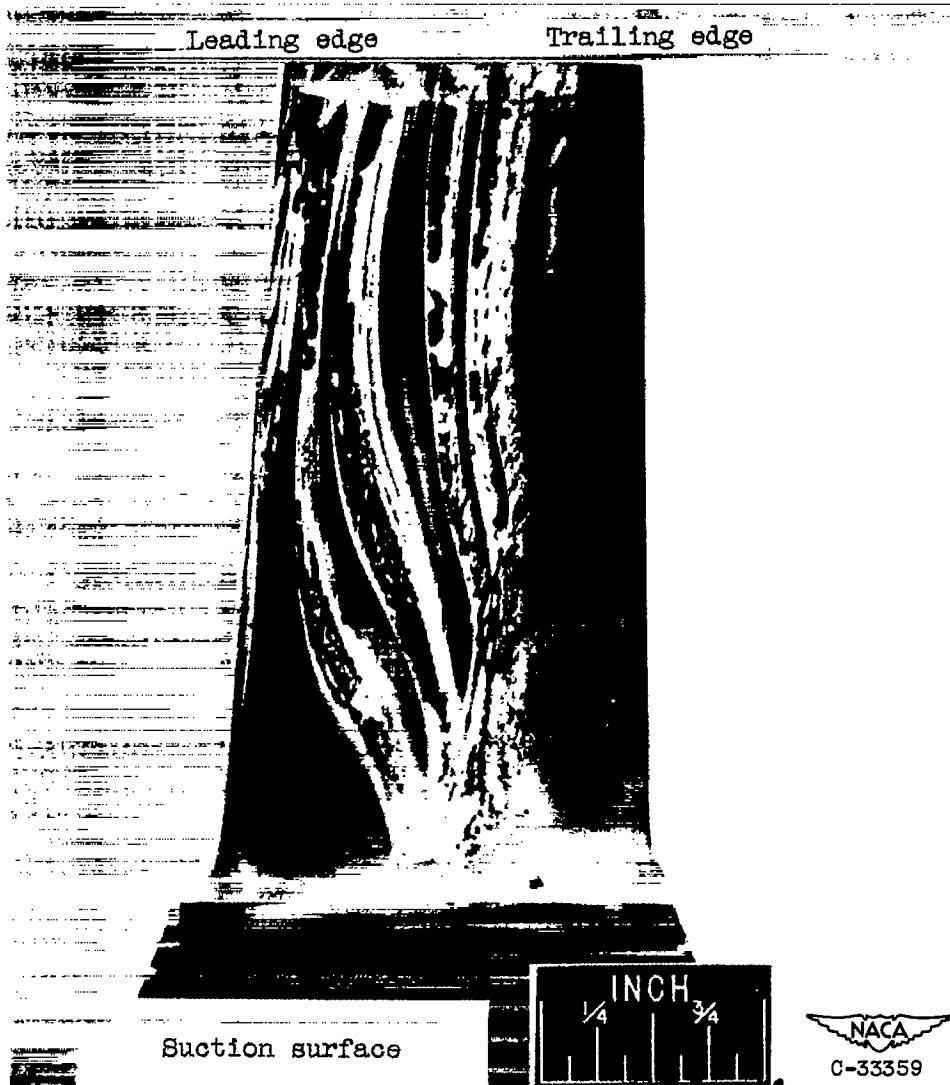
(a) Suction surface.

Typical patterns resulting from the deposition of minerals from the city water used in the spray cooling process onto the blade suction and pressure surfaces after operation with configuration ID-4(L) and (S) are shown in figures 10(a) and 10(b), respectively. As indicated in reference 1, the boundary between the wetted and unwetted portions of the blade surface is probably defined by the heavy white lines. The orderly pattern of the lines of deposition which extend progressively farther back from the leading edge on the suction surface and farther upward in a spanwise direction on the pressure surface evidently corresponds to increasing values of coolant flow. This difference between patterns on the suction and pressure surfaces, the former presenting a

spanwise or vertical interface between the wetted and unwetted sections and the latter presenting a horizontal interface, would seem to indicate a major difference in the spray dispersion over the two blade surfaces.

Figure 10. - Deposits on blade surfaces after engine operation at rated speed. Configuration type - stator diaphragm inner-ring orifices near trailing edge, ID-4(L) and (S).

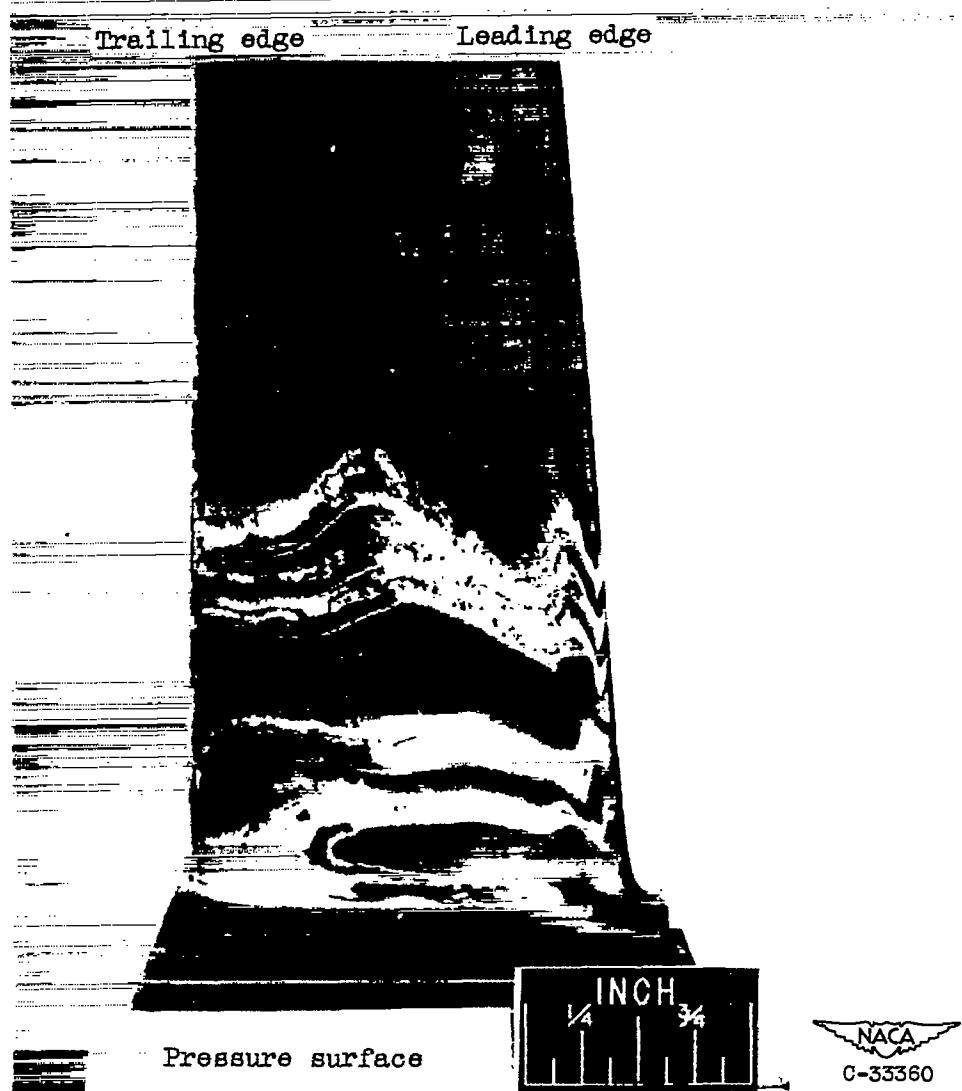
(b) Pressure surface.

On the basis of these patterns the flow mechanism can readily be visualized for the suction surface; however, this is more difficult insofar as the pressure surface is concerned. The analysis of reference 1 indicates that at rated engine speed, a water velocity relative to the rotor of approximately 2000 feet per second is required in order for the water spray to strike the rotor blades at the aerodynamic gas entrance angle. In the case of configuration ID-4(L) and (S), with which the patterns of figure 10 were obtained, it is reasonable to conclude that the spray could not have been accelerated to this velocity in the short distance between the injection orifices and the rotor. Consequently, the spray entrance angle relative to the plane of rotation is less than the aerodynamic entrance angle and the water strikes primarily the suction surface. The pattern indicates that the water spray is slung radially along the suction surface and that with increasing flow rates, the degree of surface coverage from leading to trailing edges is increased. Several possible flow mechanisms can be postulated to account for cooling on the pressure surface. One obvious assumption is that cooling on this surface may be achieved primarily by conduction rather than by spray cooling. The validity of this assumption was checked in an approximate manner. The heat input to the blade was calculated using a gas-to-blade convection coefficient of approximately 200 Btu per hour per square foot per °F (the same coefficient used in reference 4 in calculating blade temperatures) and neglecting any possible temperature drop occurring through such a water film as may exist along the blade surface. Then by means of a simple heat balance the temperature differences through the blade were calculated for runs made at several coolant flows at various blade locations and were compared with measured temperature differences. The results of these calculations were inconclusive, indicating that conduction alone could account for the temperature differences encountered only in a few instances. Neither could a trend be established as to specific locations on the blade where conduction could account for the temperature differences encountered.

The difference between the spray pattern shown in figure 10(b) and that shown on the blade with the eroded tip which will be discussed later (fig. 11) is primarily due to the different methods of injection

Figure 10. - Concluded. Deposits on blade surfaces after engine operation at rated speed. Configuration type - stator diaphragm inner-ring orifices near trailing edge, ID-4(L) and (S).

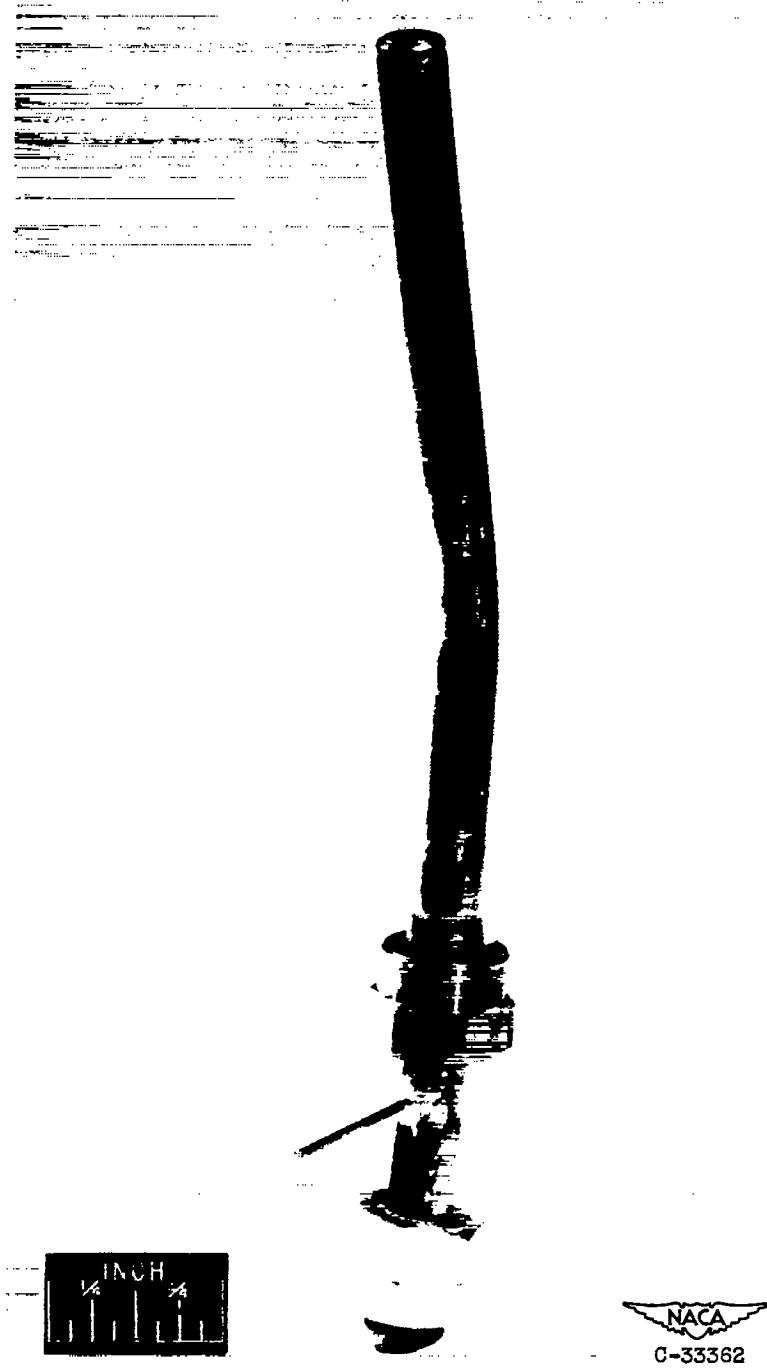
and the spray bar used in the present investigation. Figure 12 indicates the condition of an Inconel spray bar after approximately 1 hour of rated speed operation both with and without spray cooling. It is apparent that the combination of gas forces and gas temperature has bent the bar after a relatively short period of operation and that prolonged operation would probably have resulted in failure of the spray bar. Although it may be possible to provide sufficient reinforcement to prevent such bending or even to provide a means of retracting the bar from the gas stream when not in use, additional undesirable complexities would be introduced. Thus, besides its relatively low cooling effectiveness, the spray bar has other major disadvantages.

Figure 12. - Inconel spray bar after approximately 1 hour of engine operation at rated speed with and without spray cooling.
